## CASE STUDY

Water loss in a medium sized residential apartment building in London Ontario. The water usage of the building is remotely monitored using an Alert Labs Flowie on the main municipal water meter. The Alert Labs algorithms compare water usage patterns and flow rates to identify potential leaks and excess water consumption.

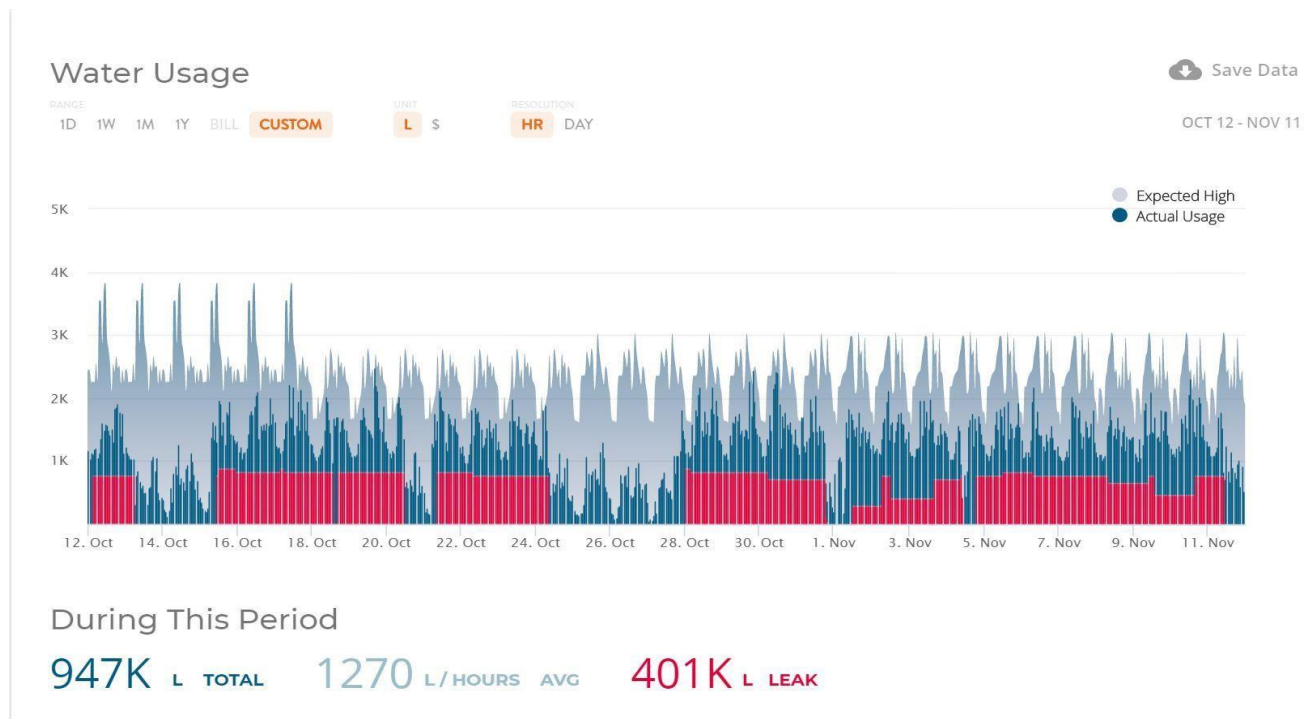
From mid-October to mid-November, the Alert Labs Flowie recorded an unusual pattern of water use at Granite House. Although there were periods with a normal water consumption during the month, there were also extended periods when the water usage was approximately double the normal usage rate. PROSHIELD was receiving intermittent alarms regarding the water use at this property.

**Water Usage Profile from October 12 – November 11: Average daily usage 30.5 m3/day.**

We analyzed the usage profile and scheduled an inspection to determine the cause(s) of the excess water use or loss. The inspection revealed a number of minor plumbing fixture leaks, (shower heads and taps), that were resolved and the building now shows a normal and consistent pattern of water usage.

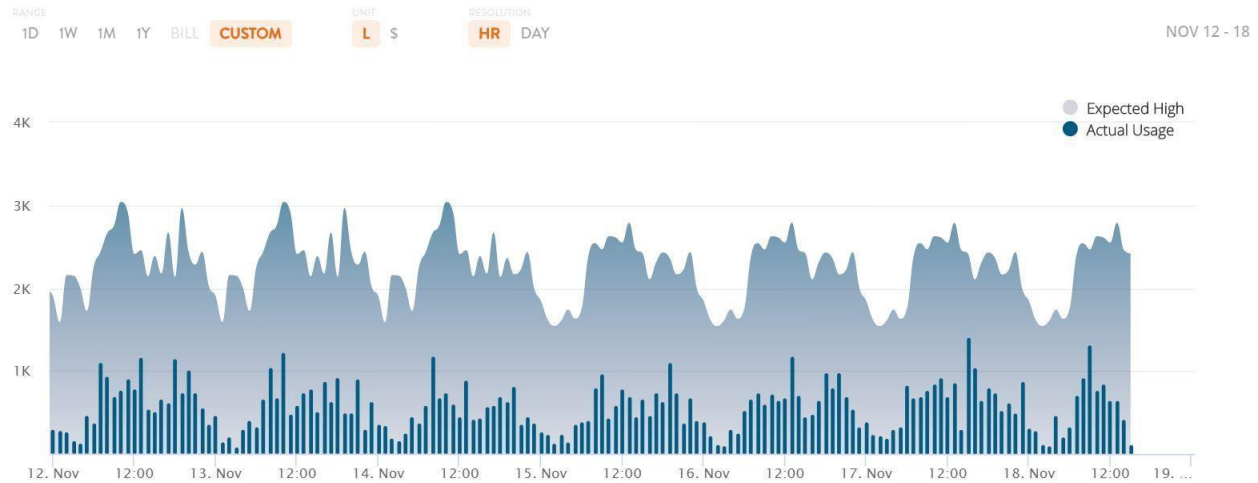
**Water Usage Profile from November 12 - 18: Average daily usage 14.3 m3/day.**

**92.8K** L TOTAL **552** L/HOURS AVG**SUMMARY:**

Since the inspections into water usage/loss have been conducted, the water consumption at this property has been reduced by approximately 50%. The resolution of this excess water loss will result in the saving of approximately \$2,200.00 per month.
